# Situation Photo Log

Monday, February 4, 2013

Kalamazoo River / Enbridge Spill

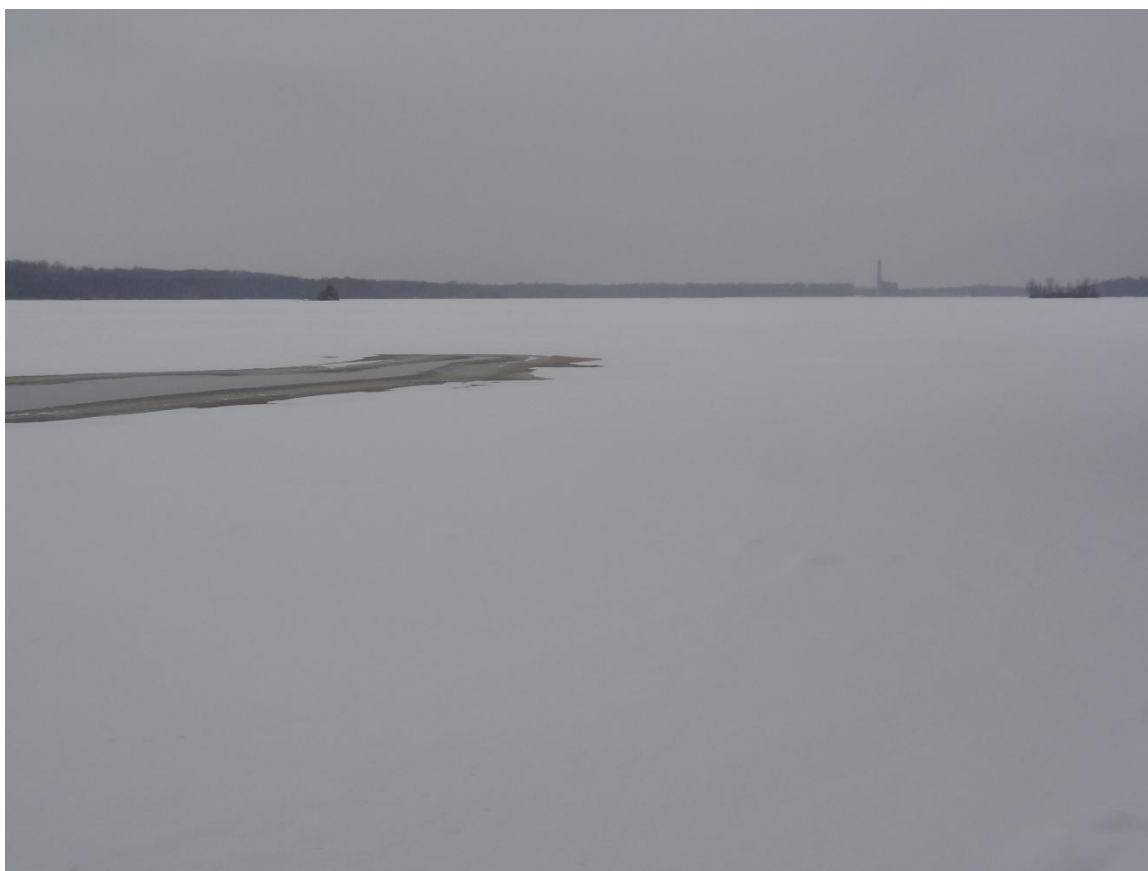
**24. Morrow Lake observed icing conditions.**
